# FAG Failure Diagnosis

Coupling Rods and Stabiliser Bushings

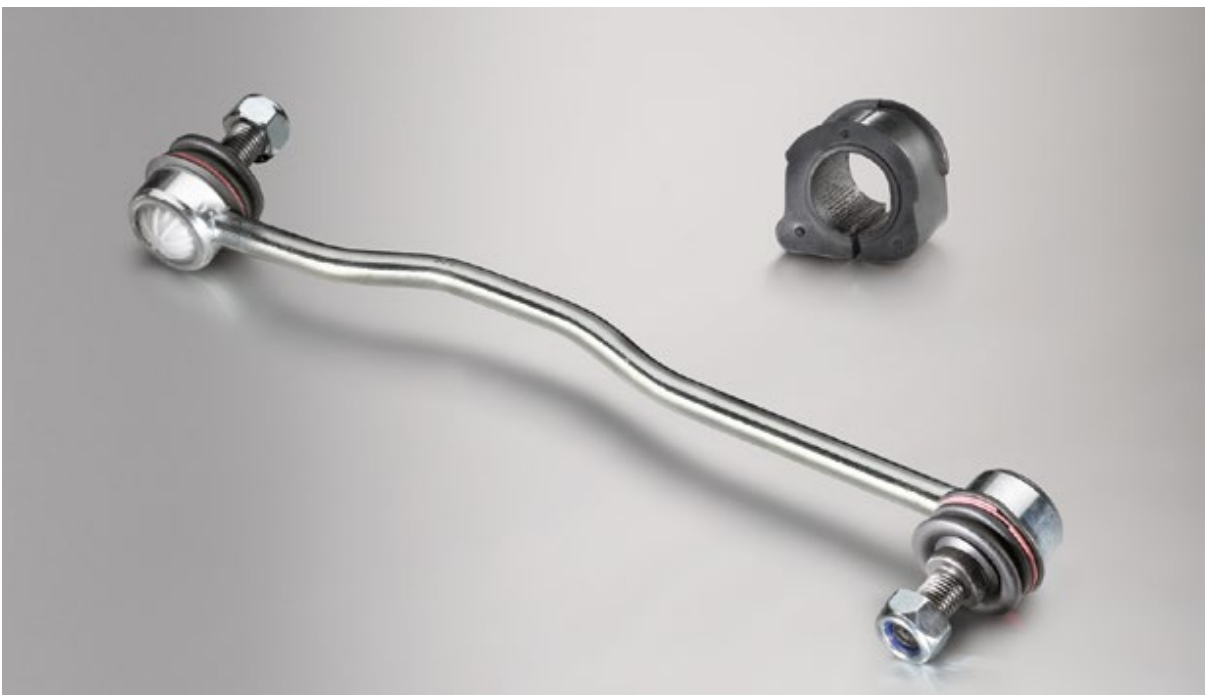
On all other axle setups rolling motion is minimised using stabiliser bars which connect to the control arm directly or via stabiliser links.

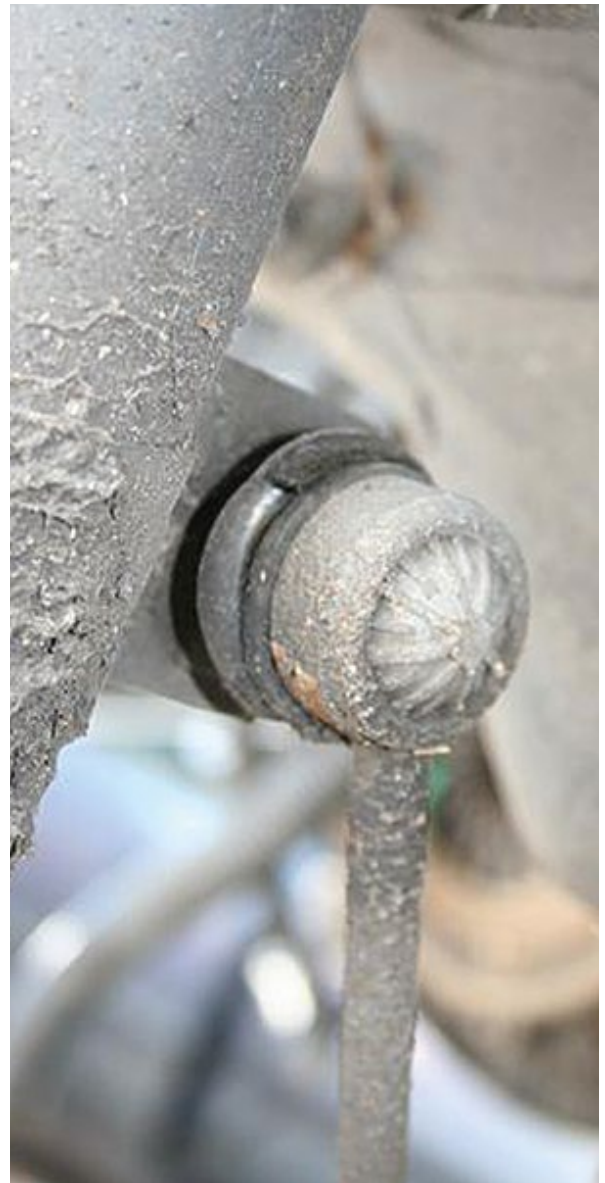
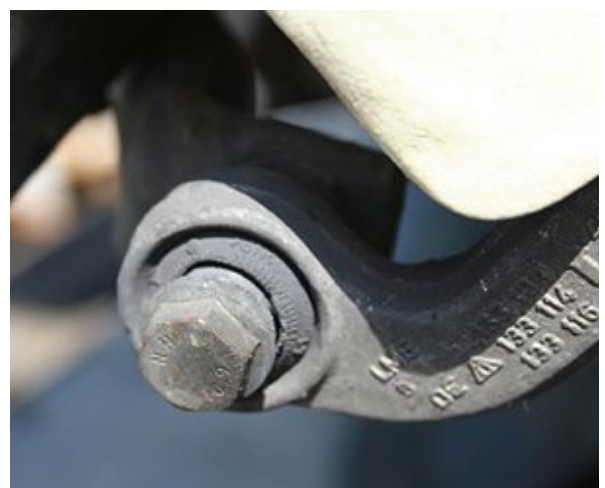
- Worn out ball heads
- Fracture or distortion
- Bushing have come loose
- Porous bushings

- Defective rubber sleeve
- Contamination by dirt or moisture
- Destruction by foreign bodies
- Fracture or wear of the ball socket
- Mechanical stress
- Incorrect mounting position

- Joints wear out
- Increased load applied on the stabiliser mount
- Loud clattering noise
- Detachment from the stabiliser

- Regular inspection of suspension components
- Adherence to specified maintenance intervals
- Immediate replacement of defective parts

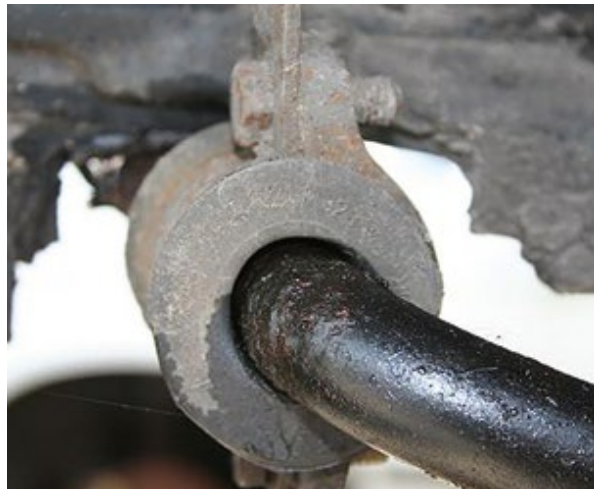
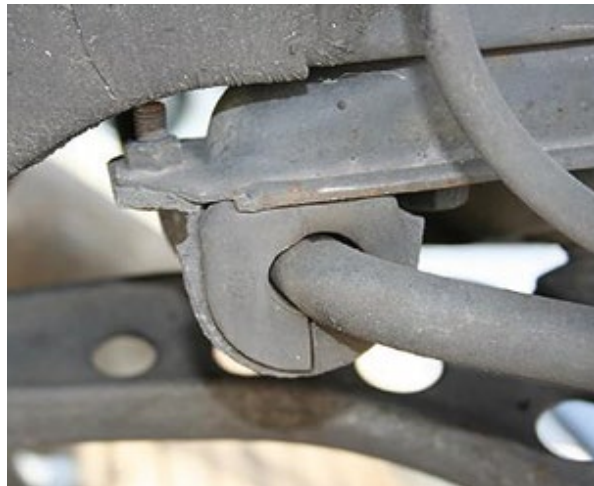
- Flaring of the rubber
- Deformation of the bushing
- Dissolving of the bushing
- Porous rubber bushings

- Bushing soaked by leaking oil
- Wear caused by vehicle rolling motion
- Service life of the rubber material has expired

- Cluttering noise at the front axle
- Increased mechanical stress on the coupling rods
- Driveability may be impaired

- Replacement of the bushings
- Check of the coupling rod condition

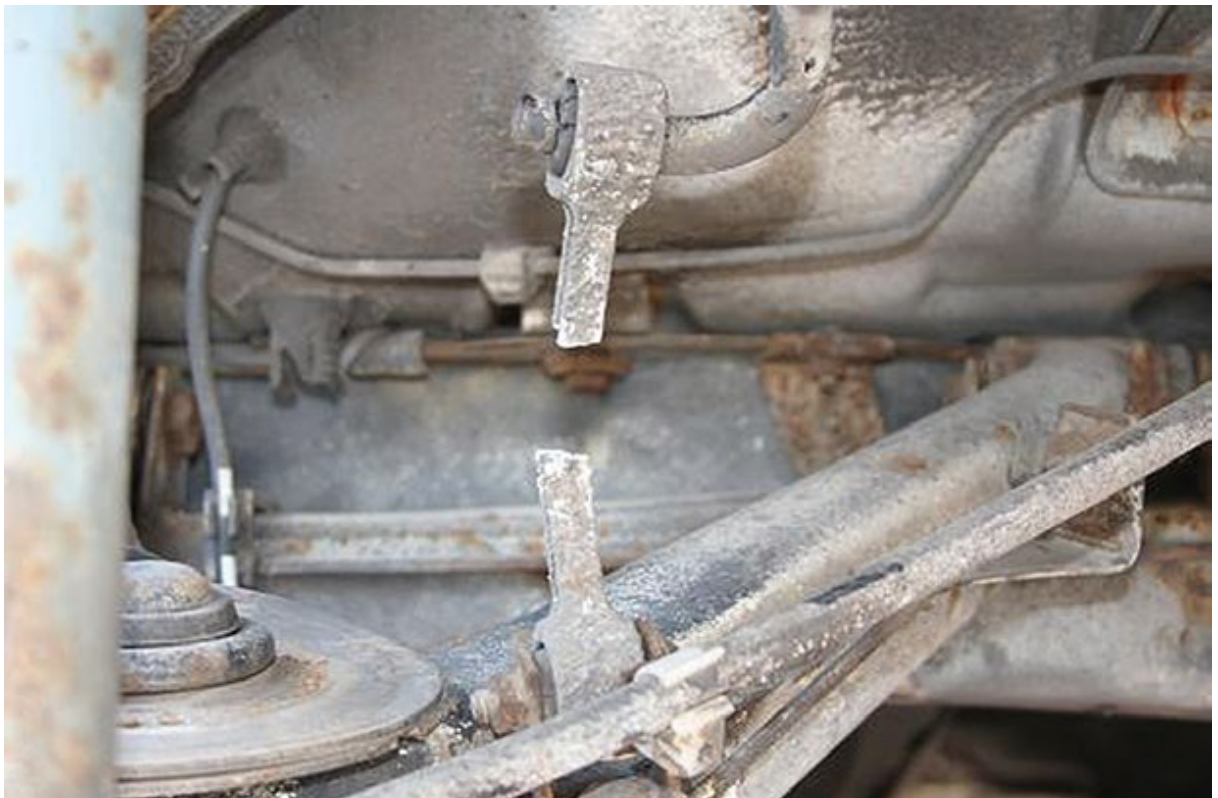
If rocking the stabiliser results in a dull noise at its linking to the coupling rod, excessive clearance in the coupling rod is the root cause. If, however, the coupling rods are in good working order, the coupling rod mounts are the likely cause of the damage. In many cases the rubber bushings are flared, porous or damaged by oil or other aggressive media.

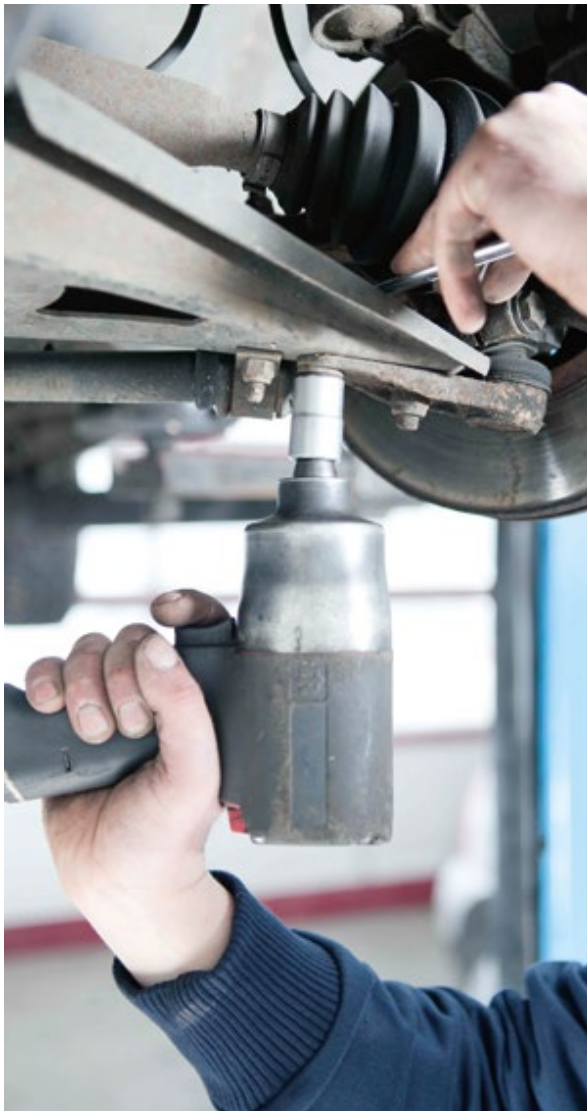
### How to replace coupling rods and stabiliser mounts

- Secure stabiliser and other components from falling off
- Do not use aggressive lubricants when mounting rubber bushings
- Different alloy materials can cause bimetallic corrosion. To ensure maximum component life only use special bolts.
- Always use new bolts and nuts.
- Always tighten the bolts and nuts to the specified torque.
- Adhere to the manufacturer's specifications at all times.
- On vehicles with headlamp levelling make a test drive to check the headlight settings and adjust if necessary.

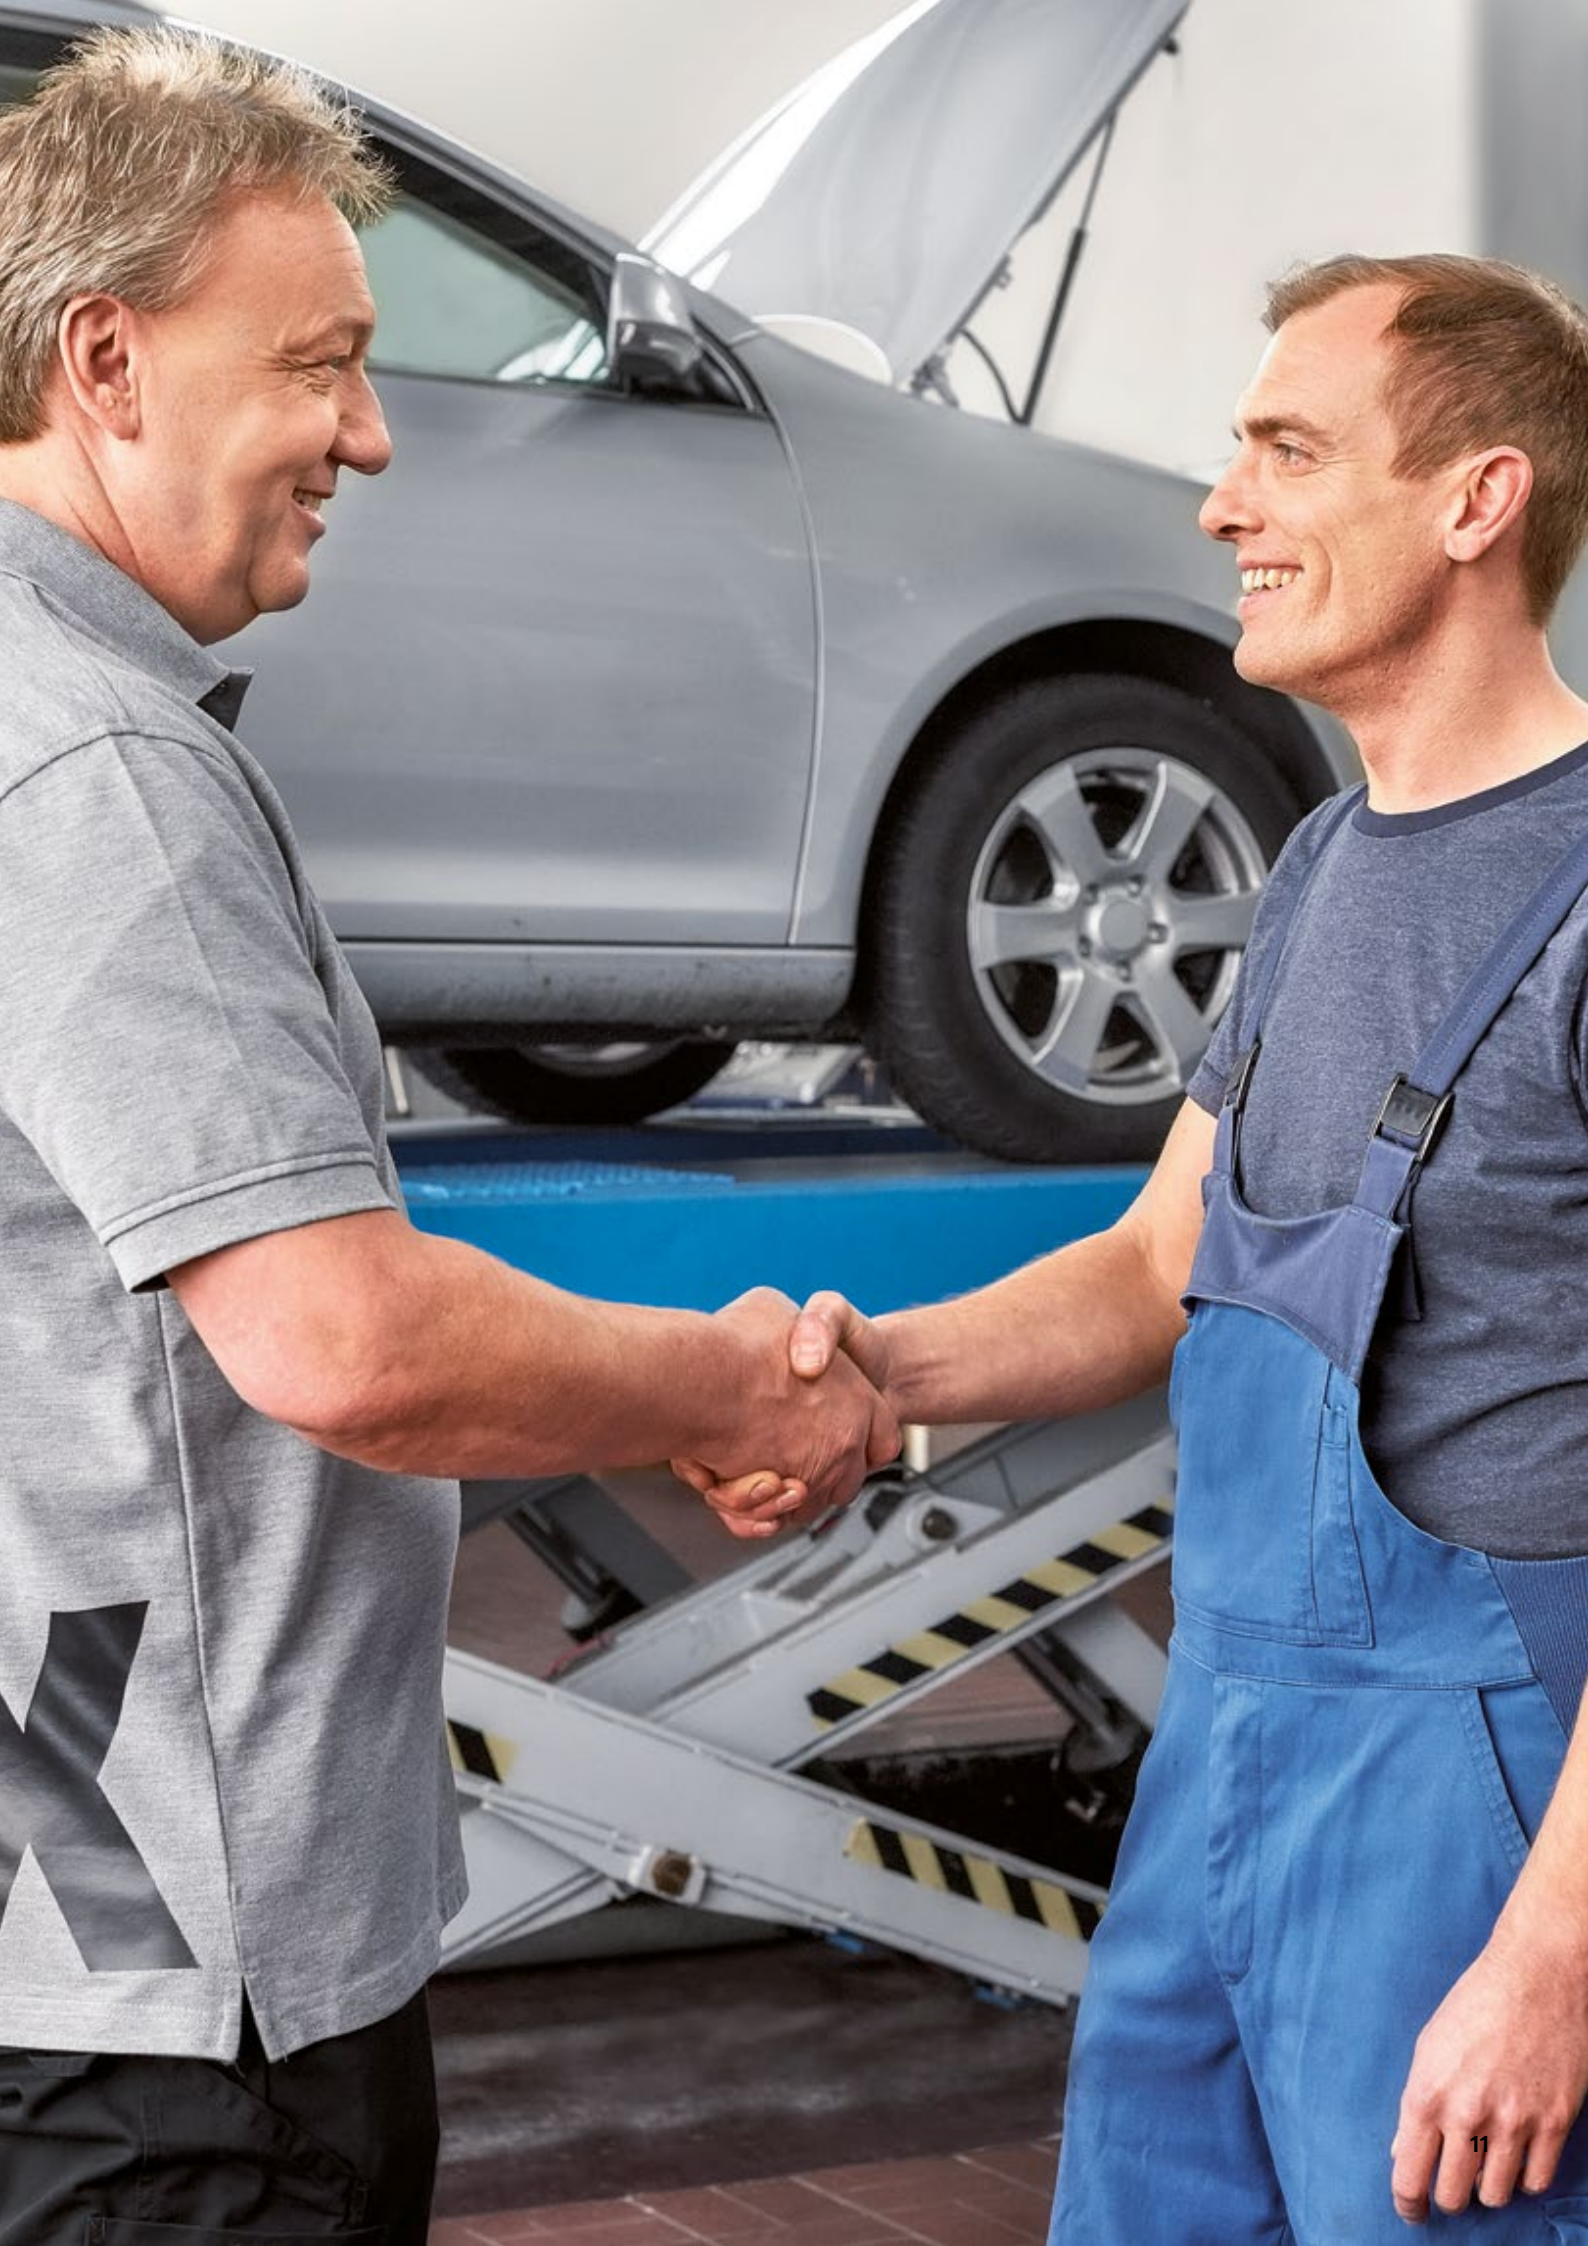
The most frequent causes of coupling rod damage are porous and/or torn sleeves and bushings. Ingressing dirt and moisture take their toll on the joints and make components fail prematurely. If the coupling rods detach from the stabiliser, this can entail serious accidents.

Failure to ensure correct linking between the coupling rod and stabiliser significantly deteriorates vehicle driveability and leads to increased rolling motion of the vehicle body.
