FAG Function and Failure Diagnosis

CV Joints

1 How CV joints work

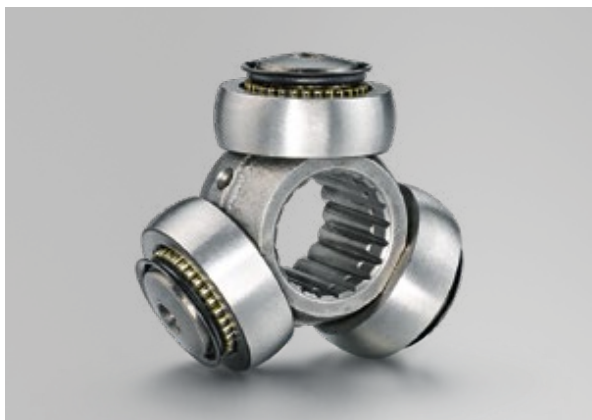
Tripod joint

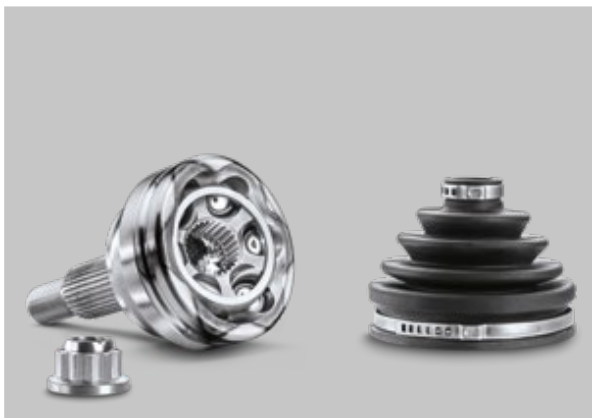
Wheel joint kit

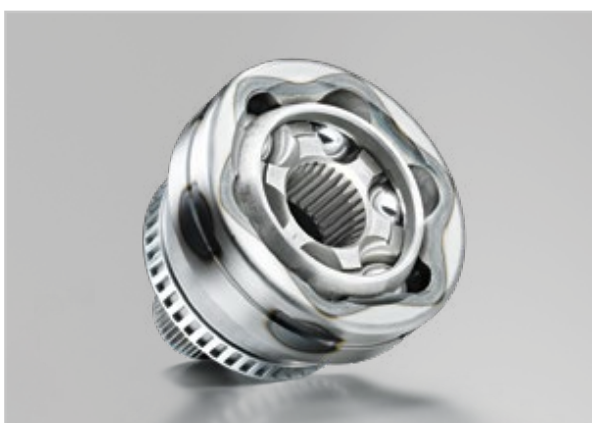
Wheel joint

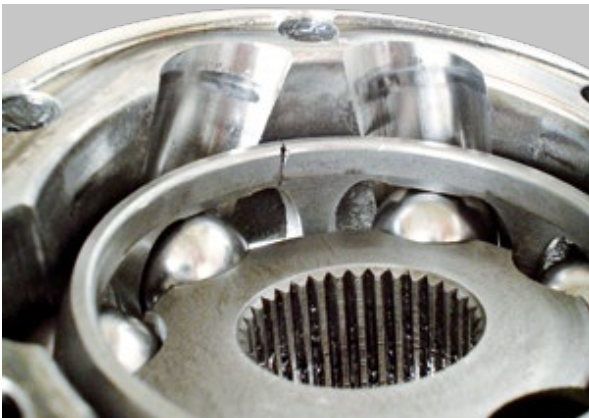
In plunging ball joints, an enlarged distance makes the core protrude too far so that the drive work is only performed at one end of the joint. Excessive tension is caused at the ends of the raceways with the inner component parts of the joint (cage, core and balls) exposed to greater wear and tear or suffering damage.

Defective plunging ball joint

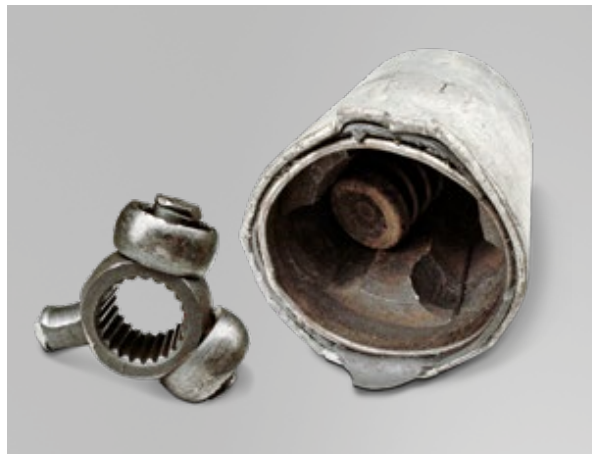
If the working distance is lengthened too far, this makes the tripod joint slide out of the holder, with a loss of drive force. In the worst case, surrounding component parts will be damaged. If the distance is shortened, the tripod joint impacts on the base of the housing, damaging the inner component parts of the gearbox.

Defective tripod ball joint

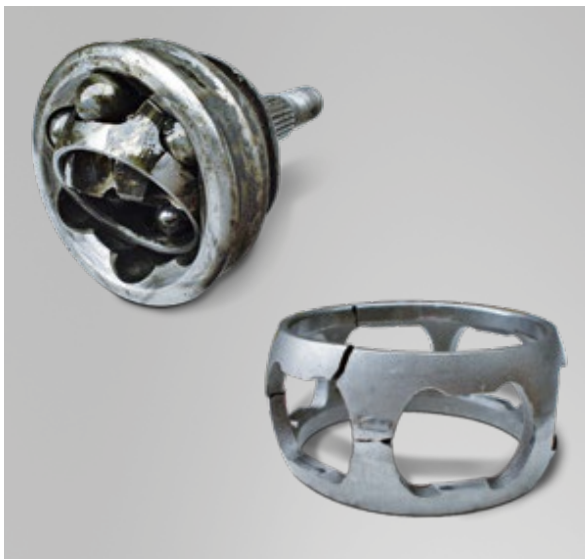
- natural wear and tear caused by the functioning of the component part (extremely rare)
- impacts or jolts, transmitted by uneven road surfaces
- jolts when removing and fitting the joint
- inadequate or excessive lubrication
- excessive tension caused by lengthening or shortening of the working distance

Broken cage

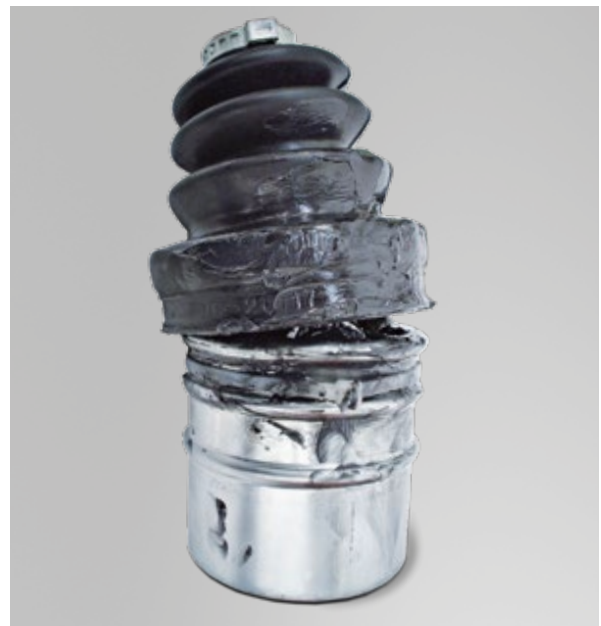
- natural wear and tear of material or aging (porosity, cracks)
- excessive lubrication
- inadequate ventilation during installation (reducing the bending angle)
- unsuitable or incorrectly fastened clamps

Incorrect fitted boot

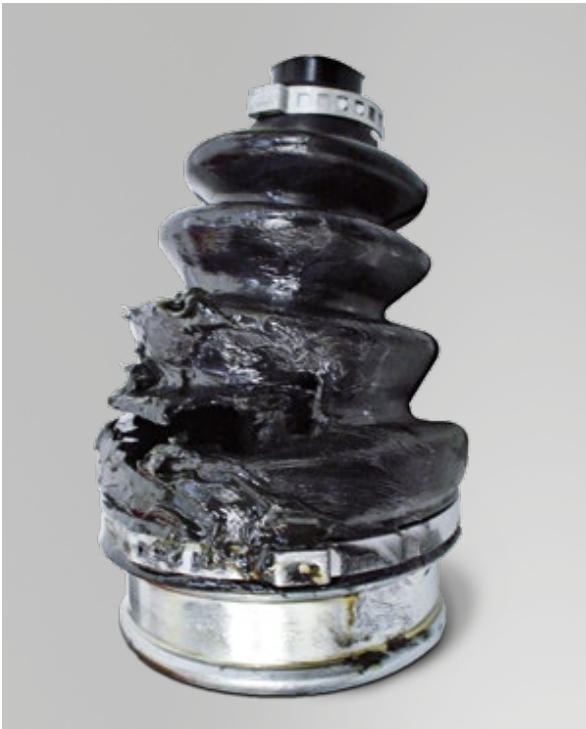
Any cracks or leaky axle boots will result in a loss of lubricant while dirt penetrates the joint. Inadequate or excessive lubrication or even unsuitable lubricants cause premature wear and tear of the inner component parts.

Defective boots
